Manhole Inspection Summary

Manhole # S13C__016MH

Location Address: **500 POPLAR GROVE ST**

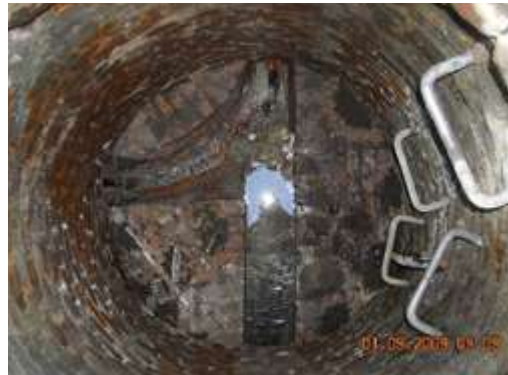
Top View

Comments **ADDED TOP VIEW PHOTO 1/9/2009**

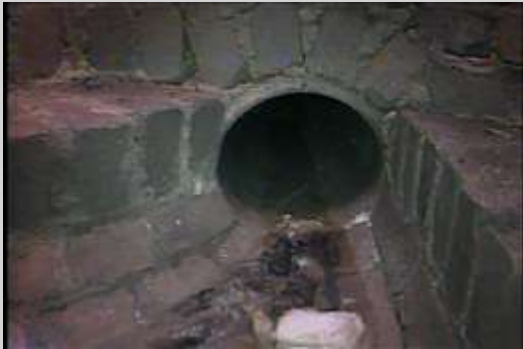
12 O'Clock Outflow

8 in. Circular Gravity Sewer
Pipe Out @ 12 O'Clock

Pipe Height: **8.4** (in.) Rod and Bar (Angled)
Pipe Material: **Clay** ☐ Pipe Lined
Invert Depth: **7.61** (ft.) Flow Characteristics: **Slow**
Deposits: ☒ None ☐ Mud ☐ Sludge ☐ Debris ☐ Grease
Silt Depth: (in.) Deposits Extent:
Infiltration: **None** Pipe Seal Cond: **Sound**

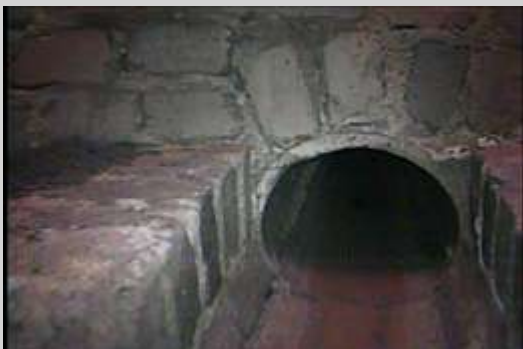
6 O'Clock Inflow

8 in. Circular Gravity Sewer
Pipe In @ 6 O'Clock

Pipe Height: **8.4** (in.) Rod and Bar (Angled)
Pipe Material: **Clay** ☐ Pipe Lined
Invert Depth: **7.58** (ft.) Flow Characteristics: **Slow**
Deposits: ☒ None ☐ Mud ☐ Sludge ☐ Debris ☐ Grease
Silt Depth: (in.) Deposits Extent:
Infiltration: **None** Pipe Seal Cond: **Sound**

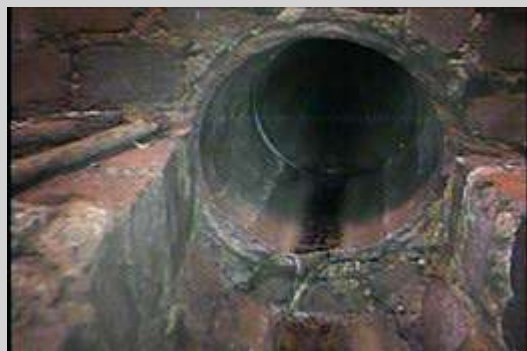
9 O'Clock Inflow

8 in. Circular Gravity Sewer

Pipe In @ 9 O'Clock

Pipe Height: **8.4** (in.) Rod and Bar (Angled)

Pipe Material: **Clay** ☐ Pipe Lined

Infiltration: **None** Pipe Seal Cond: **Sound**
